Dynamic Full Scale Tests of Median Barriers

May 1959

State of California
Department of Public Works
Division of Highways

59-04

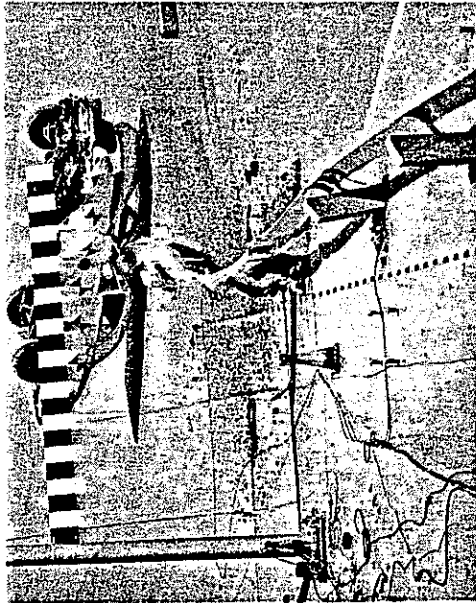
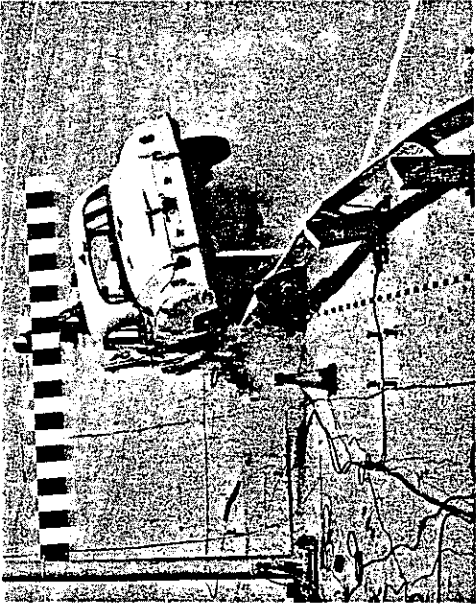
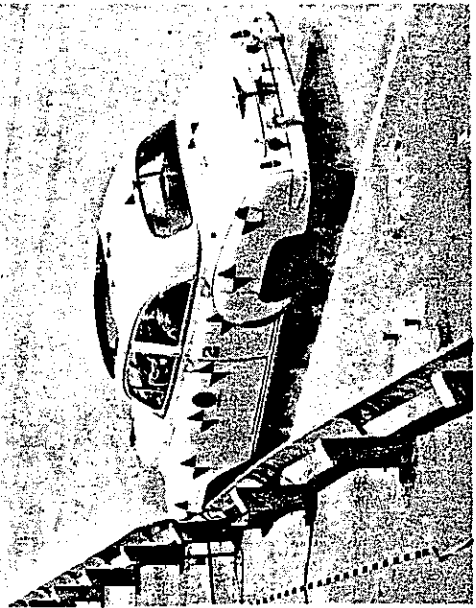
GUARDRAIL	W Section	DUMMY INJURY	Left shoulder & side injuries. Possible concussion.	TEST NO.	1
BRACKET	None	GUARDRAIL DAMAGE	3 Sections damaged beyond repair.	DATE	7-10-58
POST	8x8 D.F.	POST DAMAGE	2 Posts damaged beyond repair.	VEHICLE	Chev. 52 Sedan
POST SPACING	12'-6" O.C.	VEHICLE DAMAGE	12 Posts out of alignment.	SPEED	60 MPH
LENGTH OF INSTALLATION	212.5'	MAX. DYNAMIC DEFLECTION OF RAIL	48"	IMPACT ANGLE	27°
GROUND CONDITION	Dry			VEHICLE WEIGHT ...	3980
				(W/DUMMY & INSTRUMENTATION)

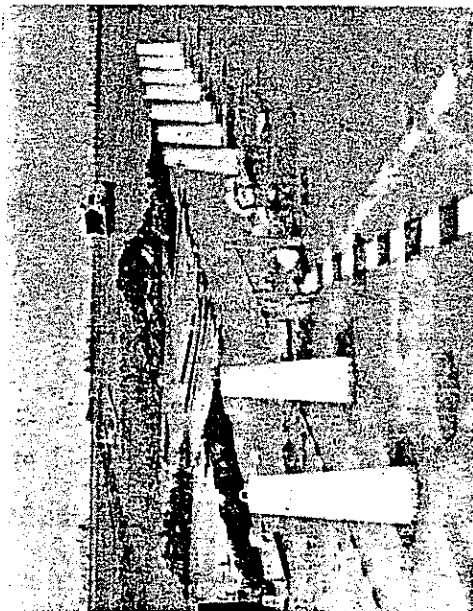
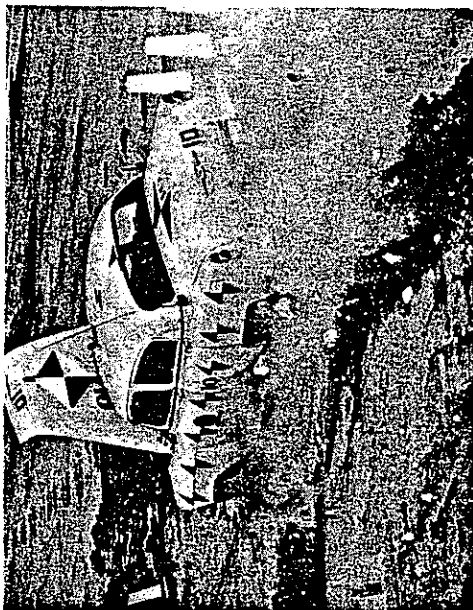
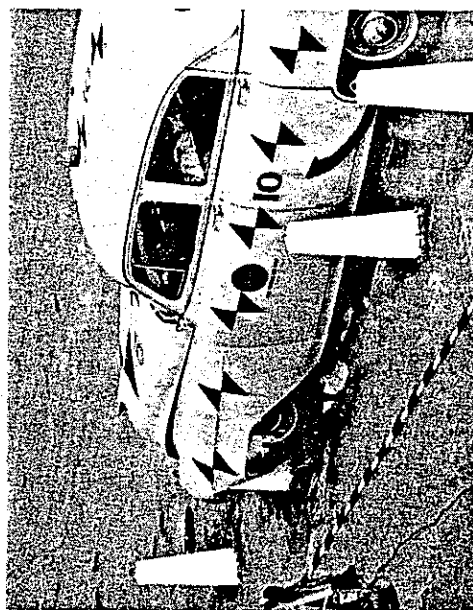
TEST NO. 9
DATE 10-15-58
VEHICLE Chev. 54 Sedan
SPEED 60 MPH
IMPACT ANGLE 28°
VEHICLE WEIGHT ... 3970
(W/DUMMY & INSTRUMENTATION)

car. It may be true under light collisions; however, under heavy collisions as presented by Test No. 9 (Exhibit 10), a flexible mounting tends to allow the rail to pocket between the posts. This results in a rail failure and the car passing on through the railing, thus it has little value as a positive barrier.

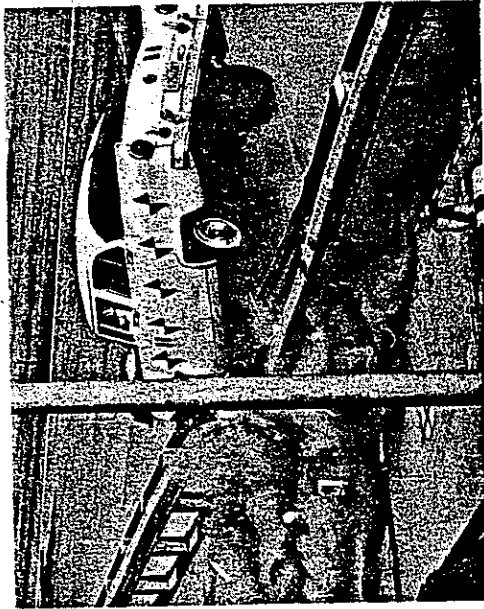
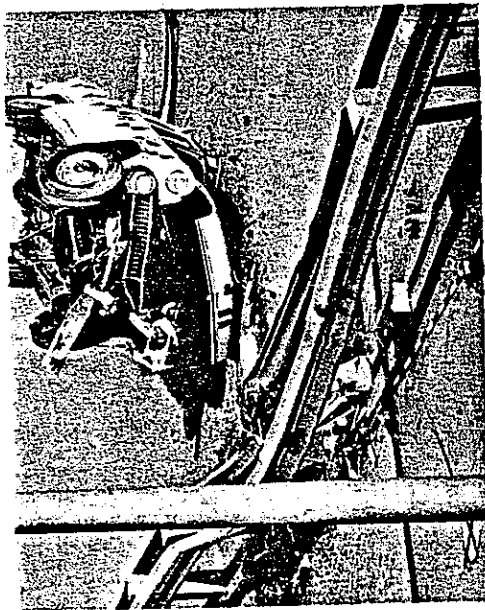
DUMMY INJURY Left shoulder & side, chest & internal injuries.
 GUARDRAIL DAMAGE 6 Sections damaged beyond repair.
 POST DAMAGE 3 Posts damaged beyond repair.
 VEHICLE DAMAGE 3 Posts out of alignment.
 MAX. DYNAMIC DEFLECTION OF RAIL... 40"

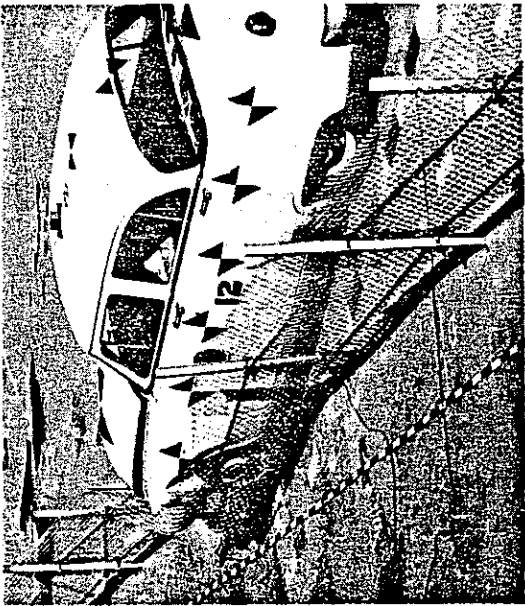
TEST NO. 12
 DATE 11-13-58
 VEHICLE Ford 52 Sedan
 SPEED 56 MPH
 IMPACT ANGLE 27 °
 VEHICLE WEIGHT ... 4002
 (W/DUMMY&INSTRUMENTATION)

DUMMY INJURY Possible neck injuries & minor bruises.
 GUARDRAIL DAMAGE 50' of Fence knocked out. No damage to Cable.
 POST DAMAGE 7 Posts damaged beyond repair.
 VEHICLE DAMAGE 6" Posts Bent.
 MAX. DYNAMIC DEFLECTION OF RAIL... 7'-2"
 VEHICLE DECELERATION (PEAK)..... Long. 69 G ... Transv. 154 G
 DUMMY DECELERATION (PEAK)..... Long 7 G ... Transv. 9.5 G

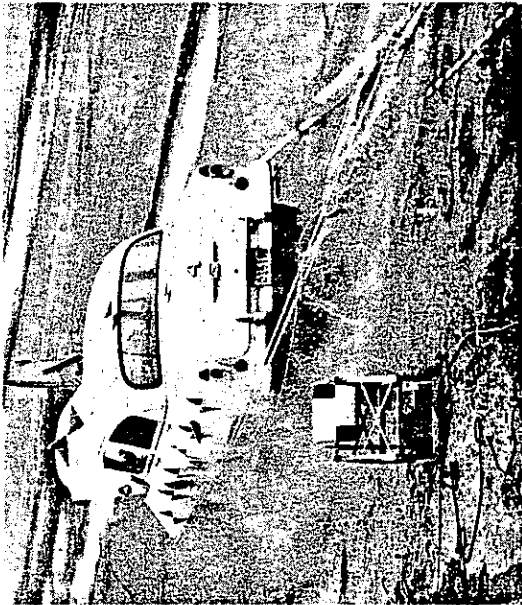
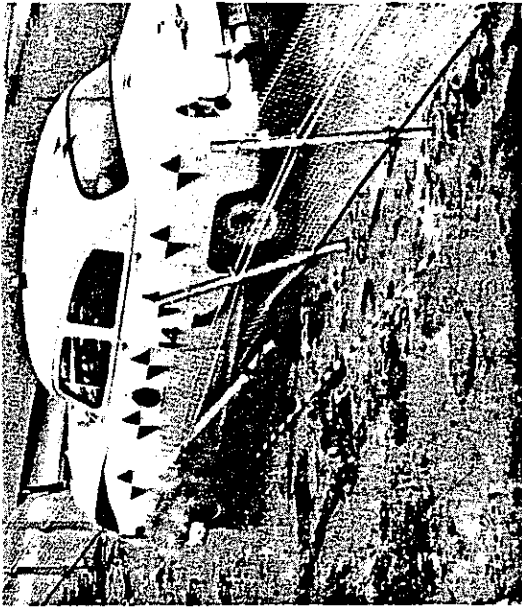
TEST NO. 14
DATE 12-26-58
VEHICLE Chev. 53 Sedan
SPEED 61 MPH
IMPACT ANGLE 31°
VEHICLE WEIGHT ... 4000
(W/DUMMY & INSTRUMENTATION)

DUMMY INJURY Minor Bruises & possible neck injuries.
GUARDRAIL DAMAGE 80' of Fence knocked out. No damage to Cables.

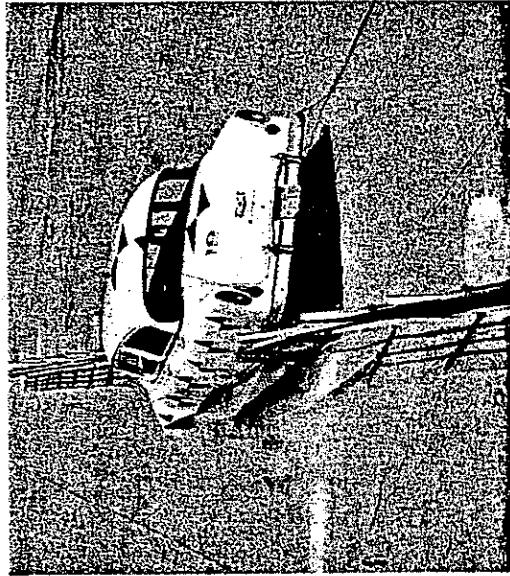
TEST NO 19
DATE 3-5-59
VEHICLE Chev. 53 Sedan
SPEED 41 MPH
IMPACT ANGLE 15°
VEHICLE WEIGHT 3700
(W/DUMMY & INSTRUMENTATION)

DUMMY INJURY Minor Bruises
GUARDRAIL DAMAGE 35' of Fence knocked out. No damage to cables.
POST DAMAGE 4 Posts damaged beyond repair.
VEHICLE DAMAGE \$ 400.
MAX. DYNAMIC DEFLECTION OF RAIL 40"
VEHICLE DECELERATION (PEAK) ... Long. 55 G ... Transv. 22 G
DUMMY DECELERATION (PEAK) Long. 3 G ... Transv. 2 G

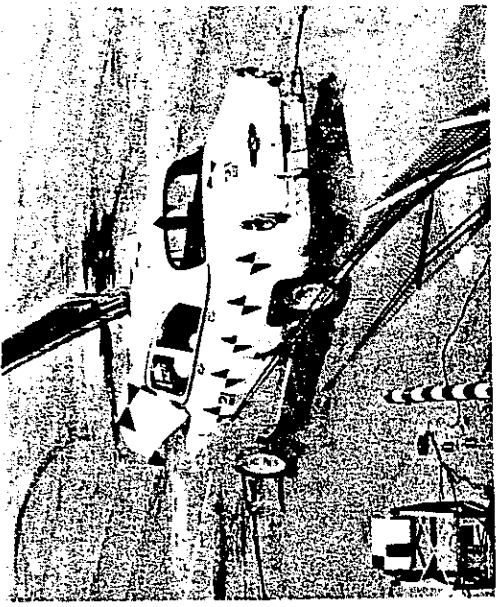
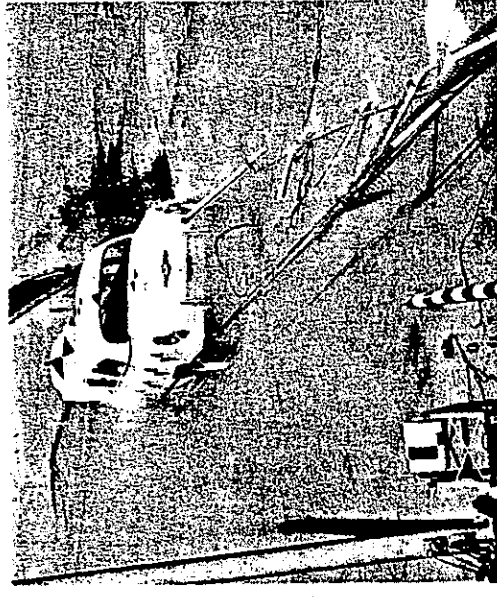
TEST NO. 21	DUMMY INJURY	Scalp laceration , possible chest injuries.
DATE 3-20-59	GUARDRAIL DAMAGE	56' of fence knocked out. No damage to cables.
VEHICLE Chev. 53 Sedan	POST DAMAGE	12 posts damaged beyond repair.
SPEED 60 MPH	VEHICLE DAMAGE	Total loss.
IMPACT ANGLE ... 31°	MAX. DYNAMIC DEFLECTION OF RAIL ...	8'
VEHICLE WEIGHT ... 3850	VEHICLE DECELERATION (PEAK) ...	Long. NG ...Transv. NG
(W/ DUMMY & INSTRUMENTATION)	DUMMY DECELERATION (PEAK)	Long. 66 ...Transv. 46
